BDC Status

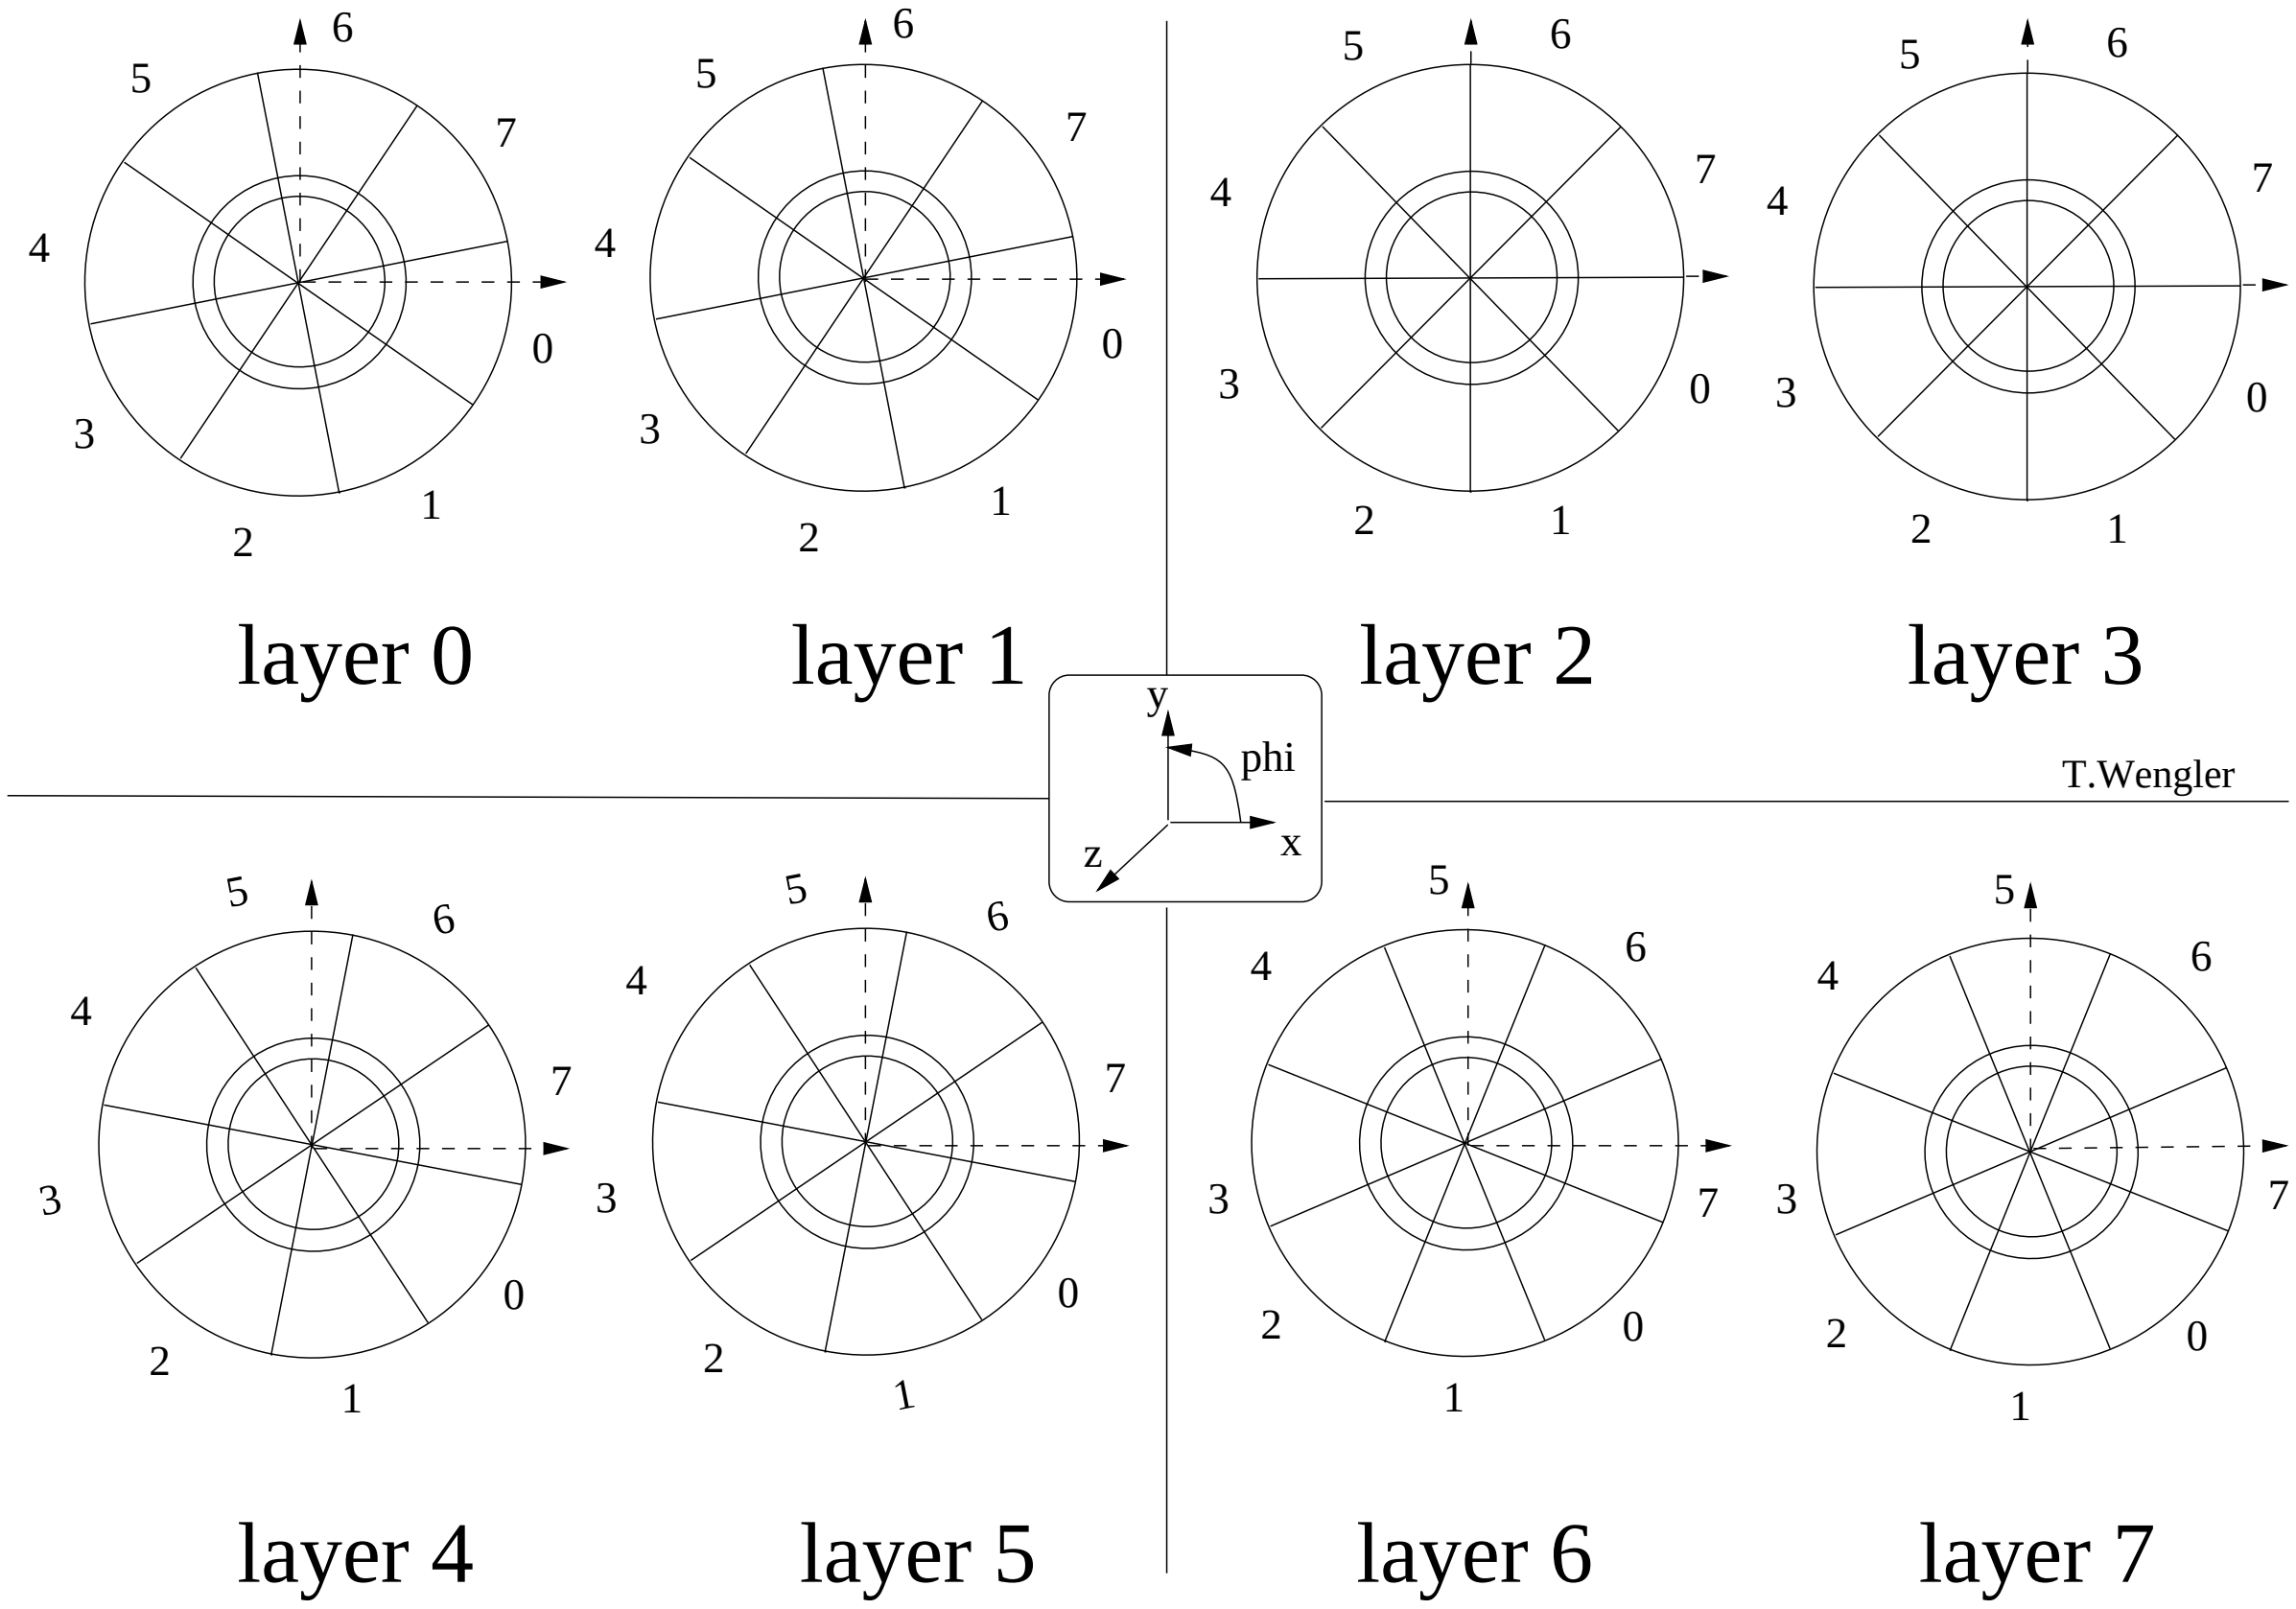
- BDC had been seriously damaged during spring shutdown as the north-hall-staff was pulling it out of the cryostat
  $\longrightarrow$ several large gas leaks at inner radius!
- Recovery after subsequent repair went very smoothly! (air-tightness better than before the accident!)

- \- in August, one half-sector had to be disconnected
  \- now 4 half-sectors out of 128 dead
  \- still at least 7 out of 8 layers active everywhere in θ, ϕ!

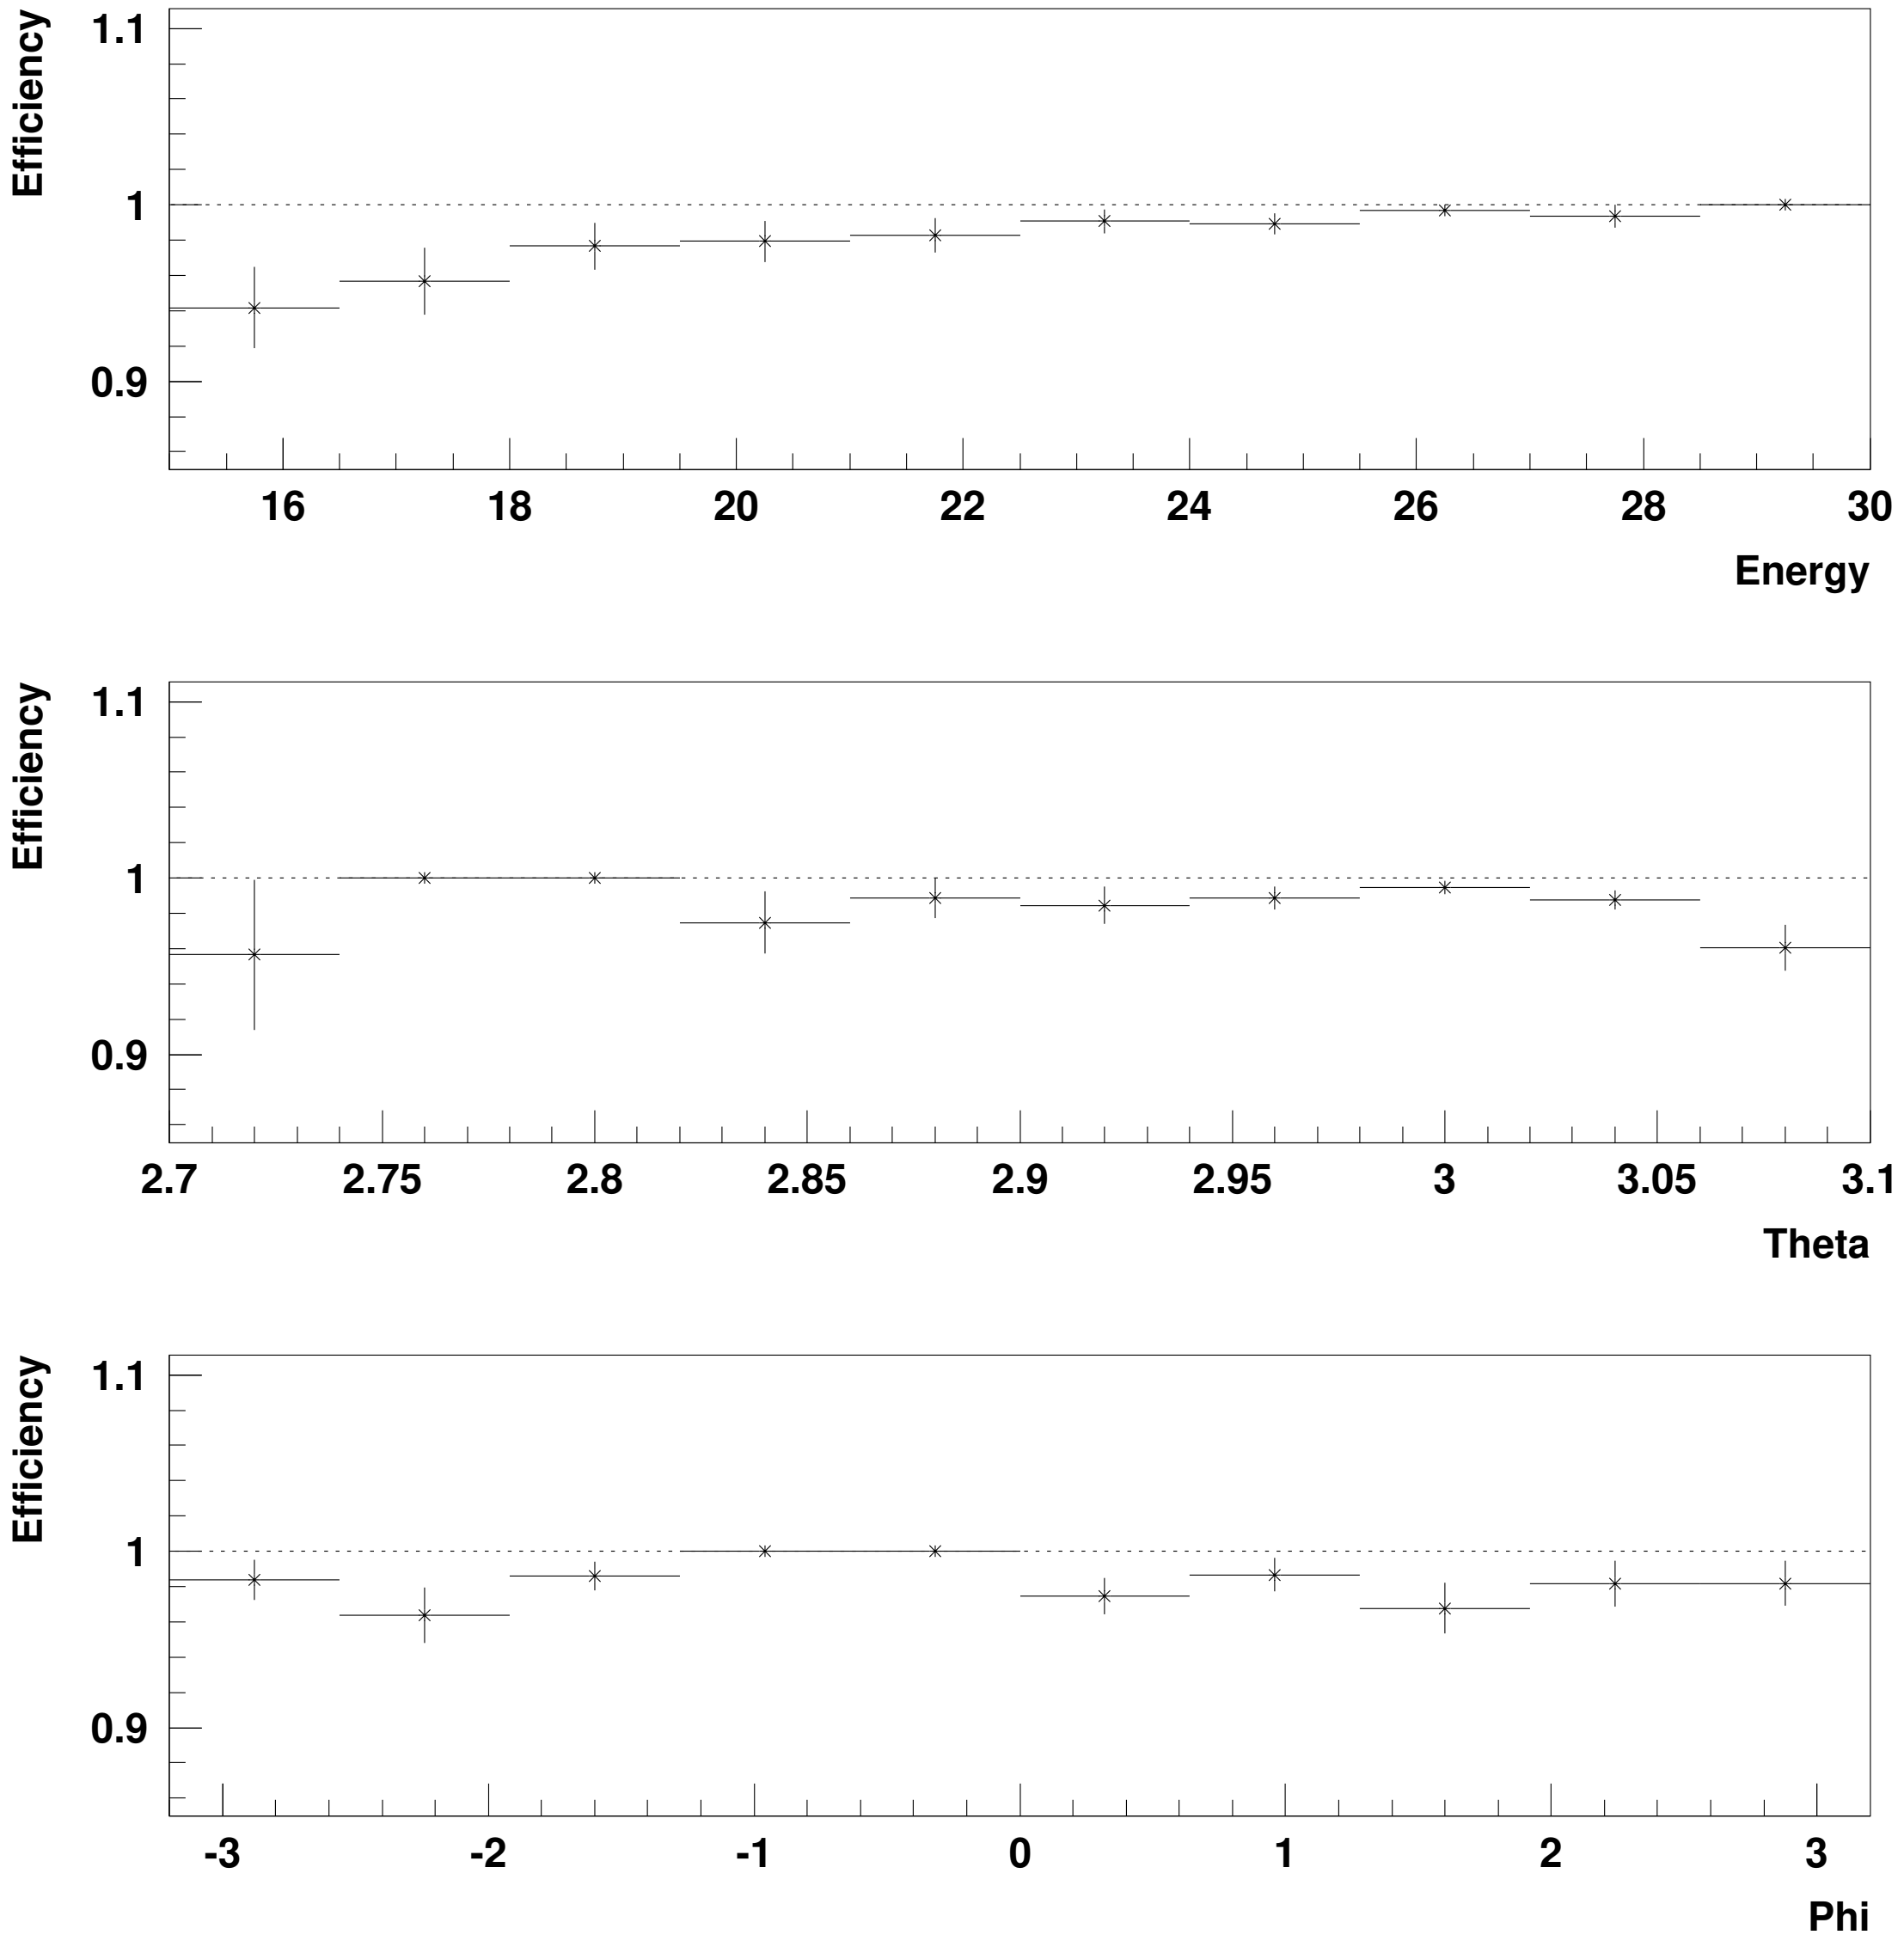
- Total BDC Efficiency is 98% !
